Geocoastal/Geotechnical Report

Admiral's Cove Beach Club, Inc.

Project Number 20-064

February 22, 2021

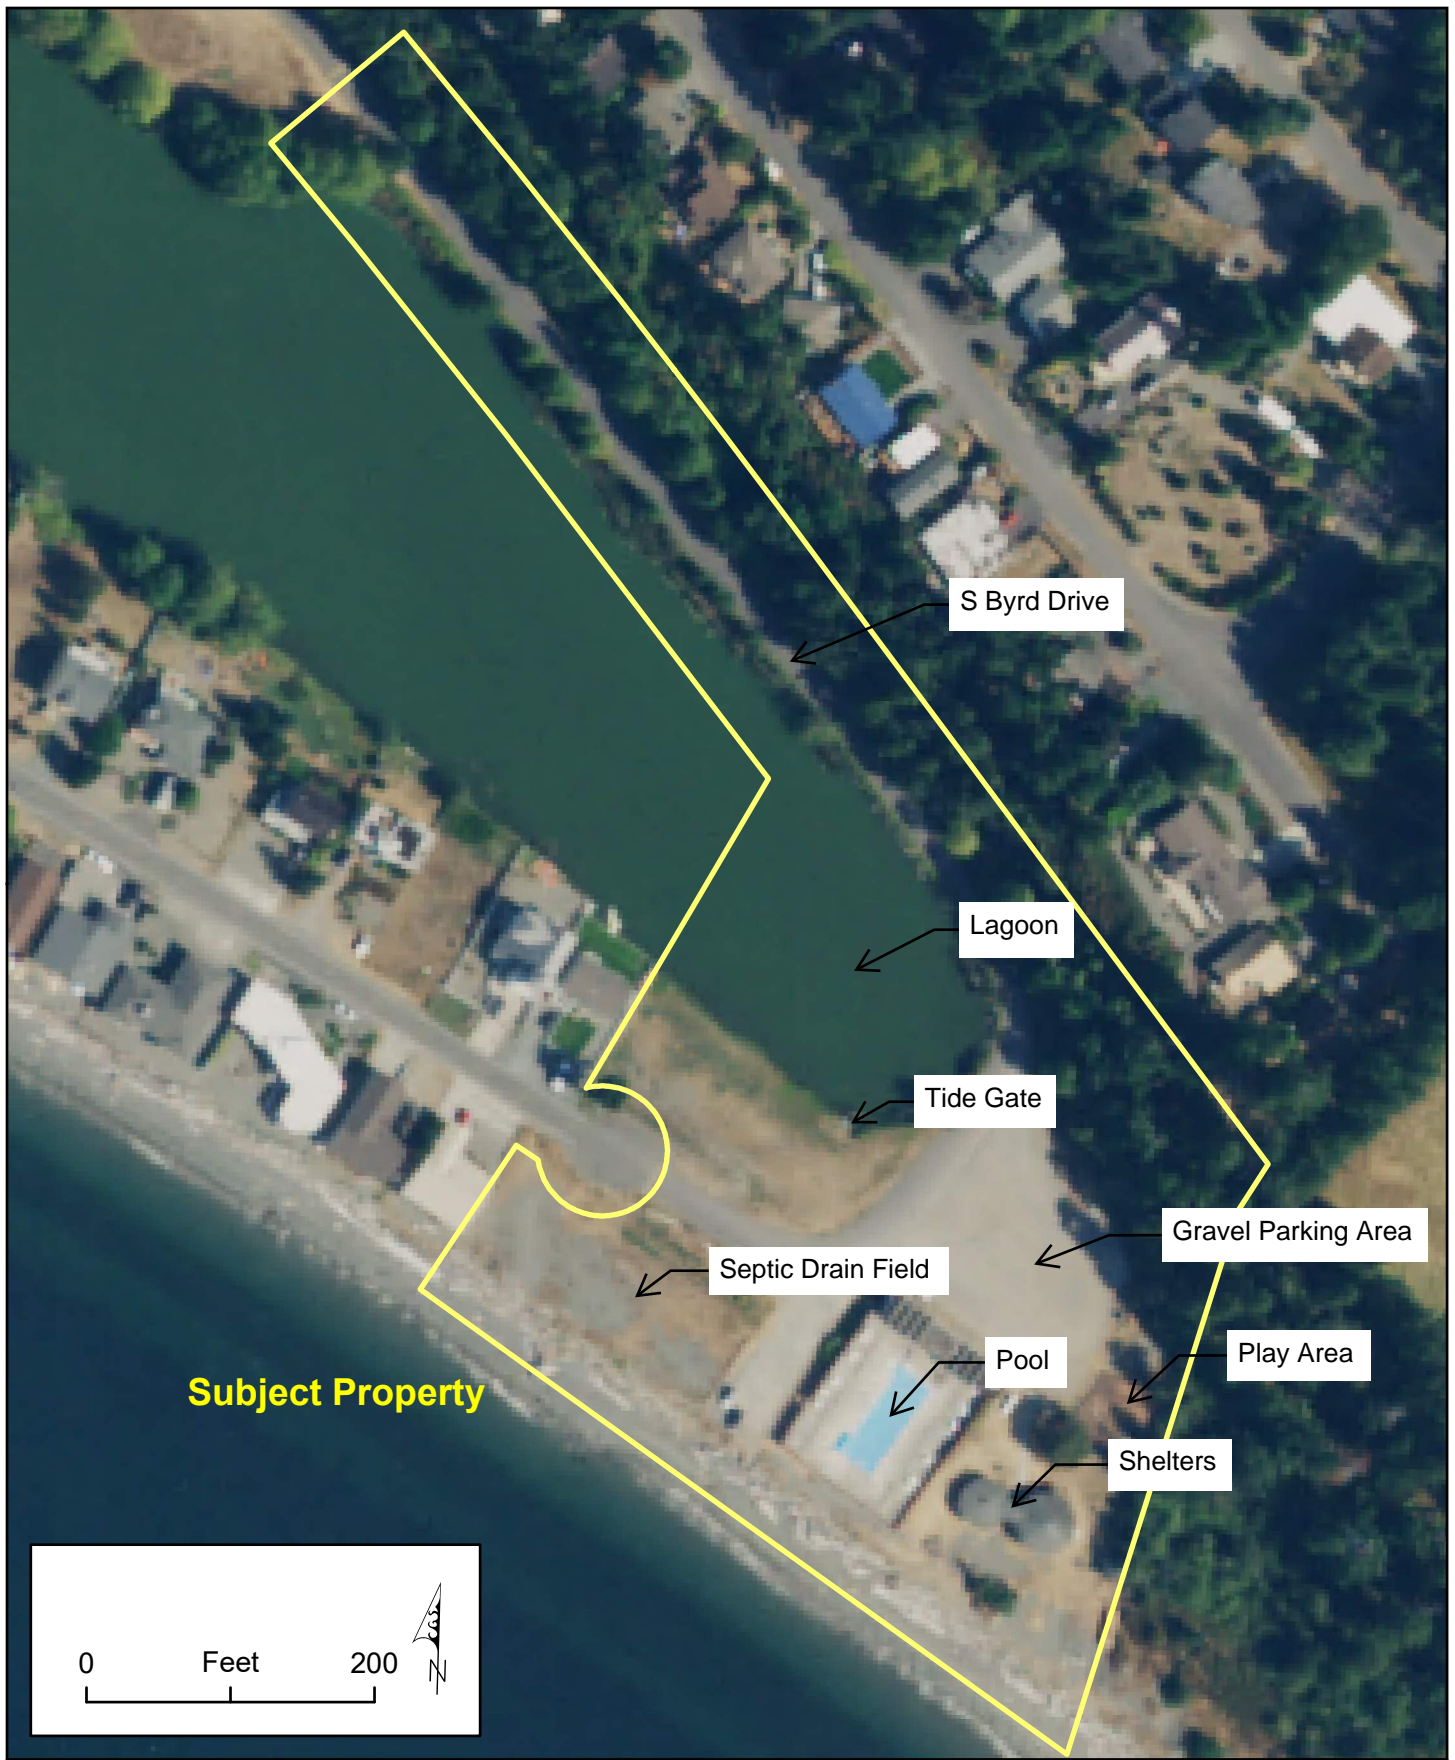
Figure 2. Site map.

Coastal erosion was experienced as we understand it primarily during the December 20, 2018 high water windstorm along with several other smaller events. The Admiral's Cove Beach Club is concerned about the integrity of the pool area and pool enclosure wall and patio, as well as the septic drainfield for the pool and community building area, which is located north of the pool (Figure 2).

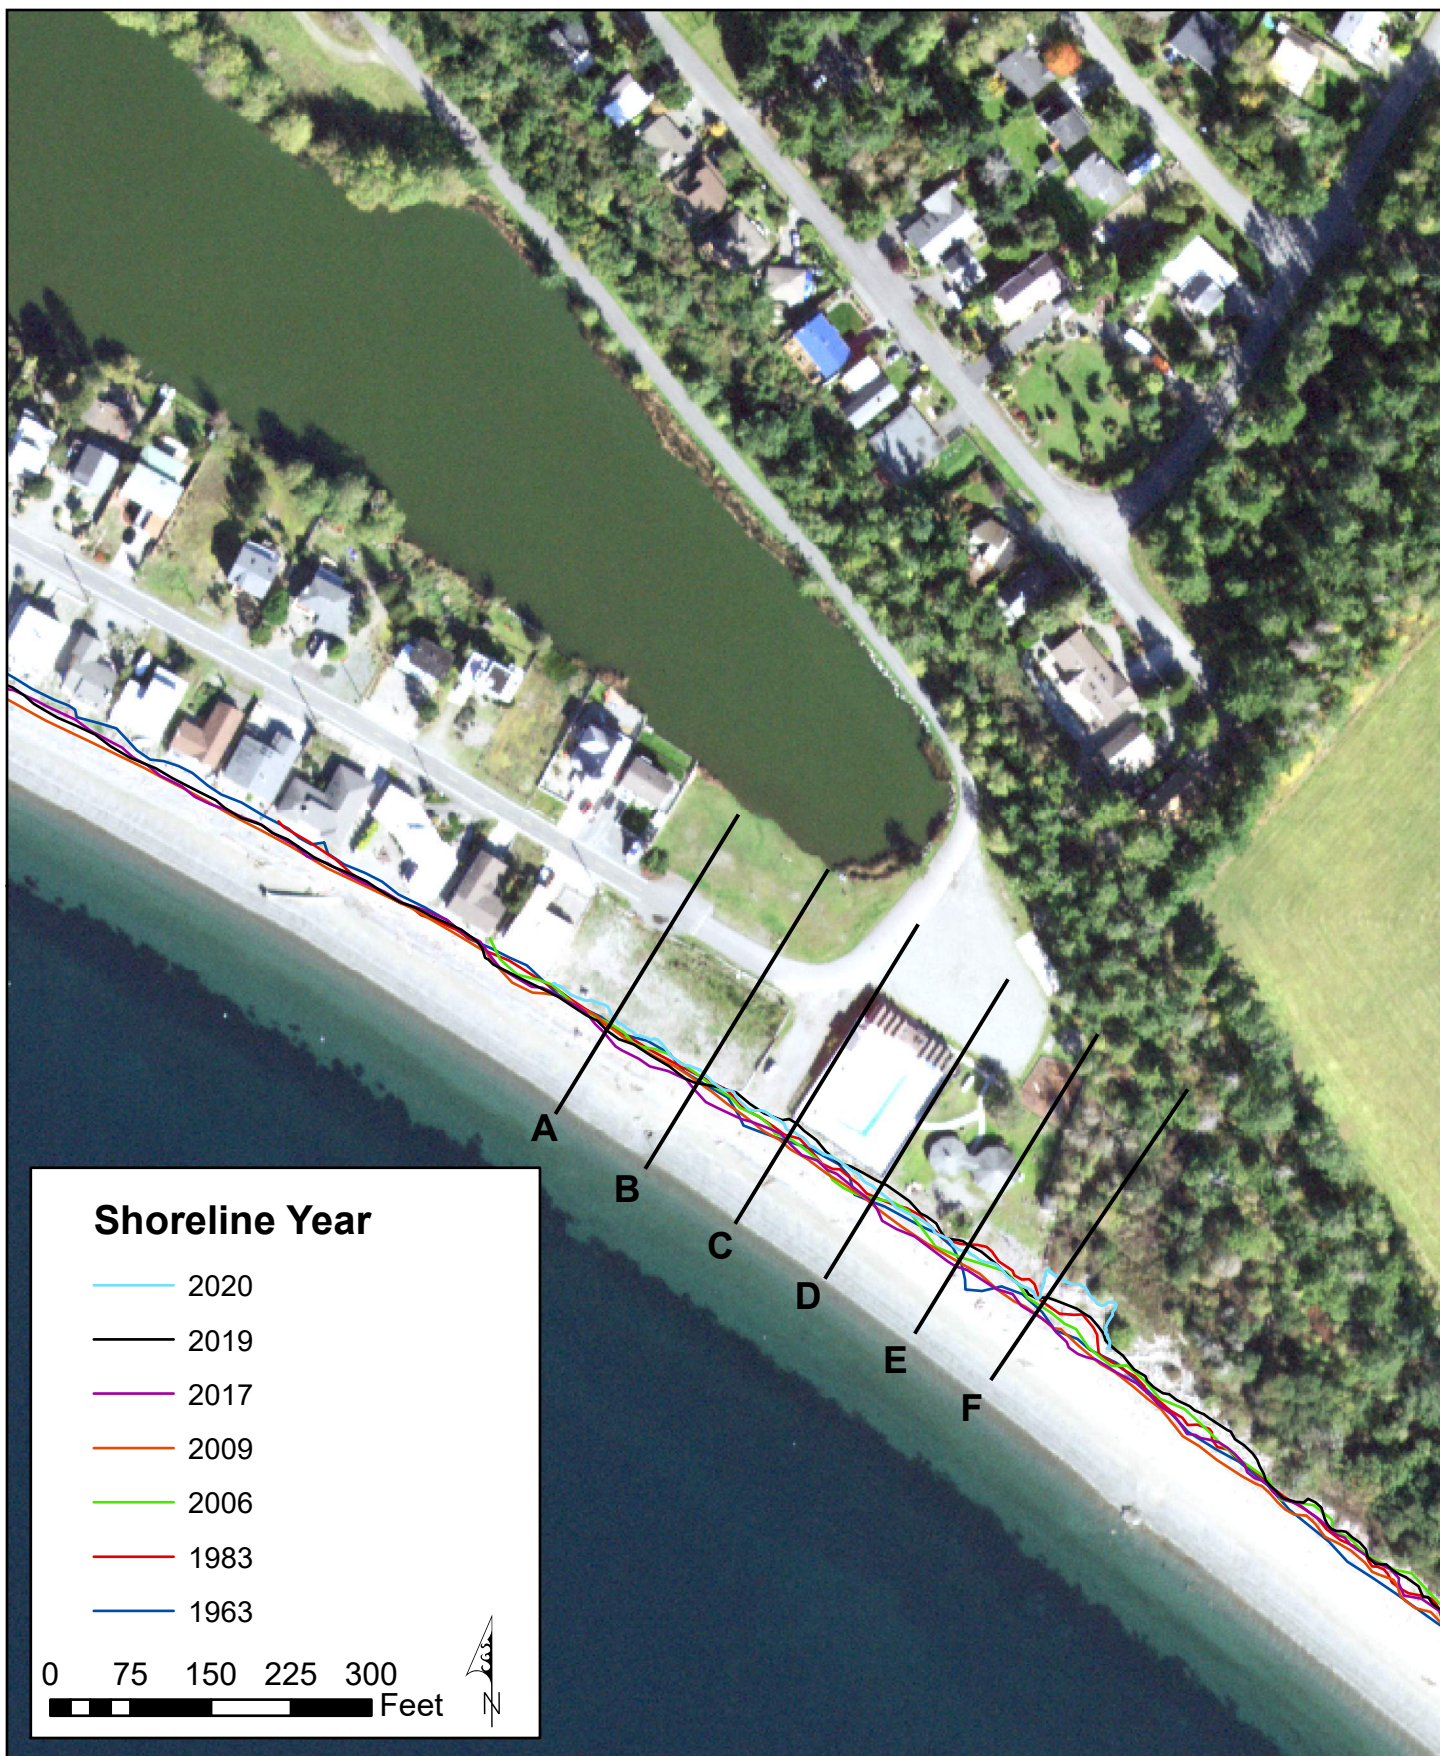
Figure 1. Historic vegetation line shoreline change map from 1963 - 2020.
Imagery from USGS EarthExplorer, NAIP/USDA, Whidbey Island CD Historic
Photo APP, Island Co. Public Works.
Admirals Cove Geotechnical Report

Using the USGS Digital Shoreline Analysis System (DSAS) (Thieler et al., 2017) tool we calculated the Net Shoreline Movement (NSM) (Table 7) and End Point Rate (EPR) (Table 8) across six transects (Figure 4). The NSM is the distance between the oldest and youngest shoreline and the EPR is the NSM dividing by the time elapsed. We analyzed the entire time span, from 1963 to 2020, as well as the last decade, from 2009 to 2019. Rates for the last decade give a good understanding of recent and current erosion rates. These annualized rates represent average rate of change across the time period. In most cases in the region, erosion occurs episodically in change events such as high water and winter storm events followed by periods of relative stability.

As there are limited ways to map the shoreline in older aerial photos with the steep gravel beach and variable image quality and georeferencing, only one shoreline proxy was available for shore change analysis for this property. Shoreline vegetation along this stretch varies along short distances and between years and seasons. It appears that the vegetation extended further waterward in 2020 than in 2019, indicating that vegetation may be regrowing after substantial losses during the December 20, 2018 storm. Just south of the property, on the south side of the fence, beach wrack and drift logs extended into the backshore moving the vegetation line substantially as measured along Transect F (Figure 4), likely from a recent high-water event associated with King Tides.

Total horizontal erosion shown in Table 7 was modest in the full time period (1963-2020) but was substantial in the recent decade. Rates shown in Table 8 were also substantial at around 2 FT/YR in the greater pool area in the recent decade.

Based on our shoreline change analysis, longer term erosion rates (1963-2020) were upwards of 0.2 FT/YR and shorter-term rates (2009-2019) had a maximum rate of 2.16 FT/YR. As the high elevation area with the pool area only extended only 2.0 FT waterward of the pool enclosure fence and concrete deck, it is reasonable to assume that without new shore stabilization the shoreline will be eroded completely back to the fence within the next few years.

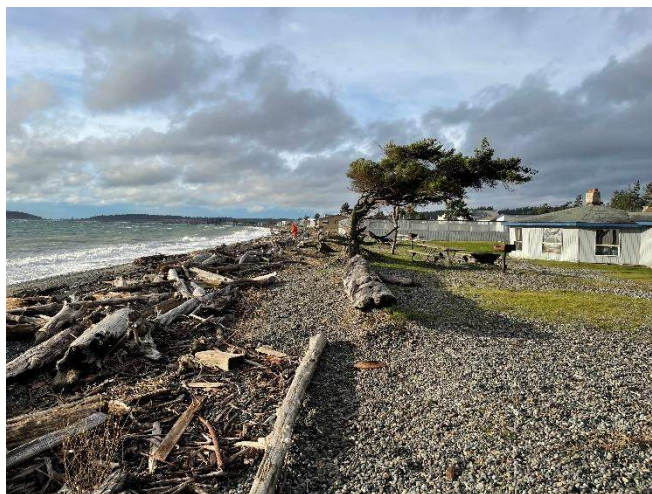
Uplands and upper beach with log line, looking northwest.

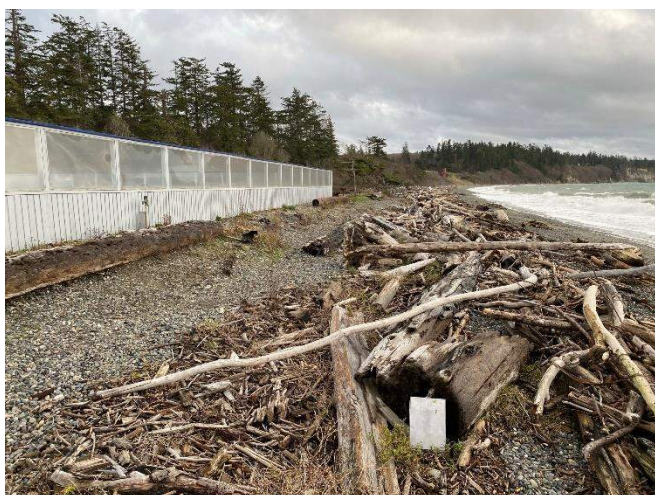
The beach was slightly narrower southeast of the pool and enclosure as compared to the southwest corner. The level high elevation area at the same elevation as the pool area only extended 2 FT waterward of the fence here. The backshore slope dropped off waterward of the pool area and included a 15 FT wide drift log zone which ended 30 FT waterward of the pool enclosure. This log area was near level at the active berm crest, which was measured at 2.0 FT below the ground at the pool enclosure (See Photo Page). The high tide beach waterward of the logs dropped off more steeply at a 3.3:1 slope over a 17 FT horizontal distance.

Waterward side of pool fence and upper beach, looking southeast.

A rock wall is proposed as the best general type of hard armor for shore protection for the pool area. This could be a sloping rock revetment or a steeper rockery wall. The armor we suggest would be as narrow as feasible and only in front of the pool building area to minimize impacts. Beach access on either end of the pool area would not be changed. As there are no other structures that are at risk close by, there is no justification to continue the rock wall all the way across the property's shoreline. We also evaluated the field northwest of the pool area and the septic drainfield appears to be setback far enough that armor protection is not necessary. Generally, the armor type and design would be to primarily mitigate storm damage going into the future as chronic beach erosion has not occurred to date at the site. Additional evaluation of the pros and cons of these different types of hard structures should be evaluated by a qualified coastal engineer. A site-specific design would then be developed.

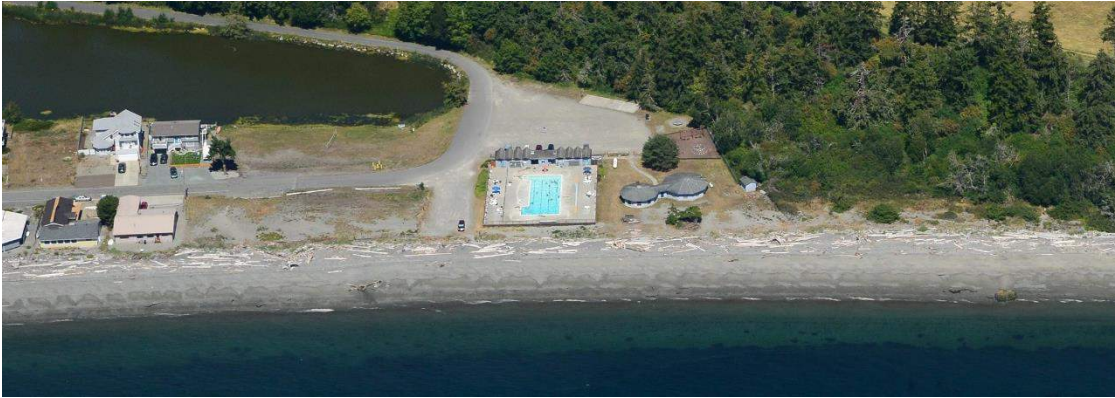
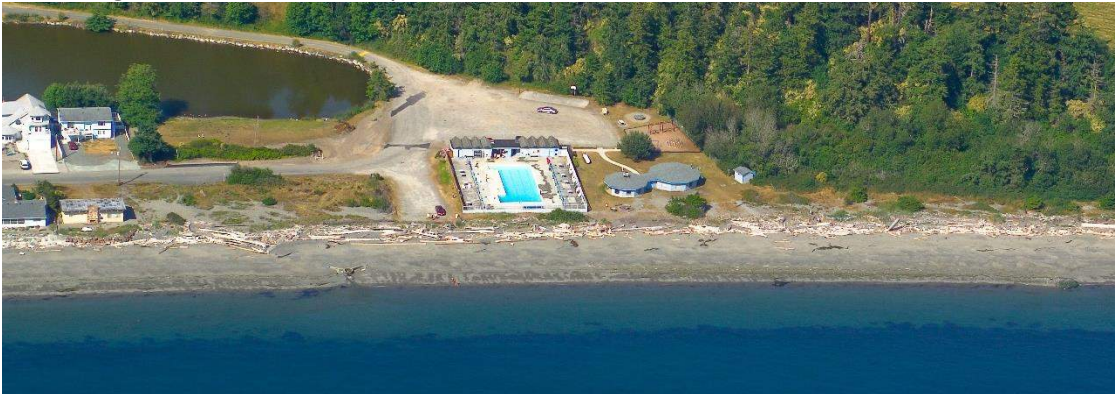
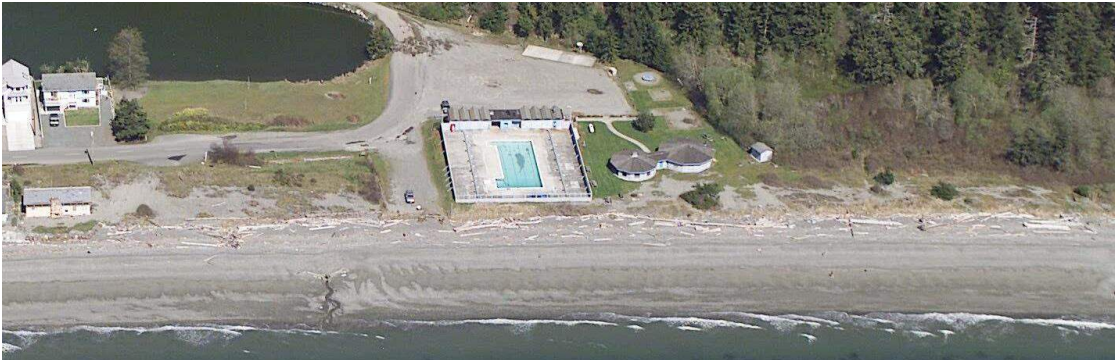
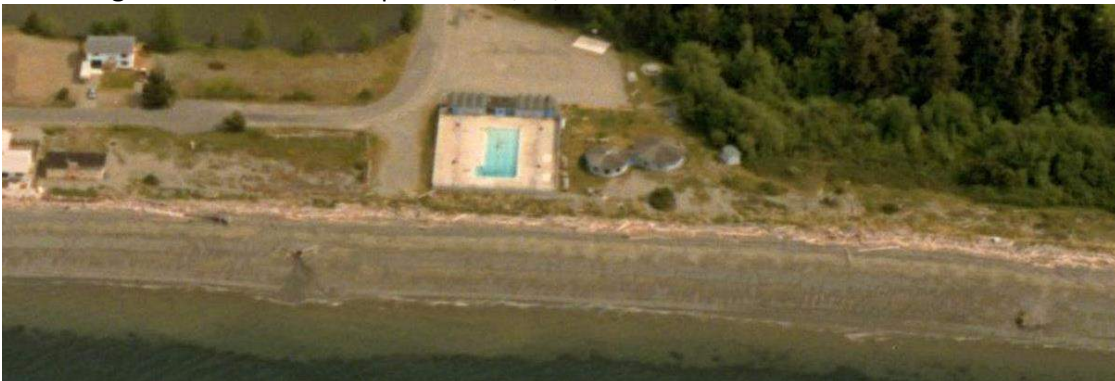
Photo Page 2. Historical aerial oblique compilation of the site (Washington Department of Ecology).

Additionally, a series of low altitude, oblique angle photographs were compiled from the Washington Department of Ecology in Photo Page 2. These span from 1993 to 2016. The backshore vegetation area can be seen to be fairly wide and very dense in the 1993 photo. This area narrows along the southeast corner of the pool area by 2001. Little changes are observed through to 2006, with the exception of a dense accumulation of drift logs present in 2006. The 2016 photo shows substantial degradation in the backshore vegetation area, likely a result of the March 10, 2016 storm and initial re-growth. The newer air and ground photos show a considerably reduced backshore area after 2016.
